# Southern WV Safety Alert

Two mantrip accidents recently occurred at two separate mines due to inadequate preoperational checks and maintenance.

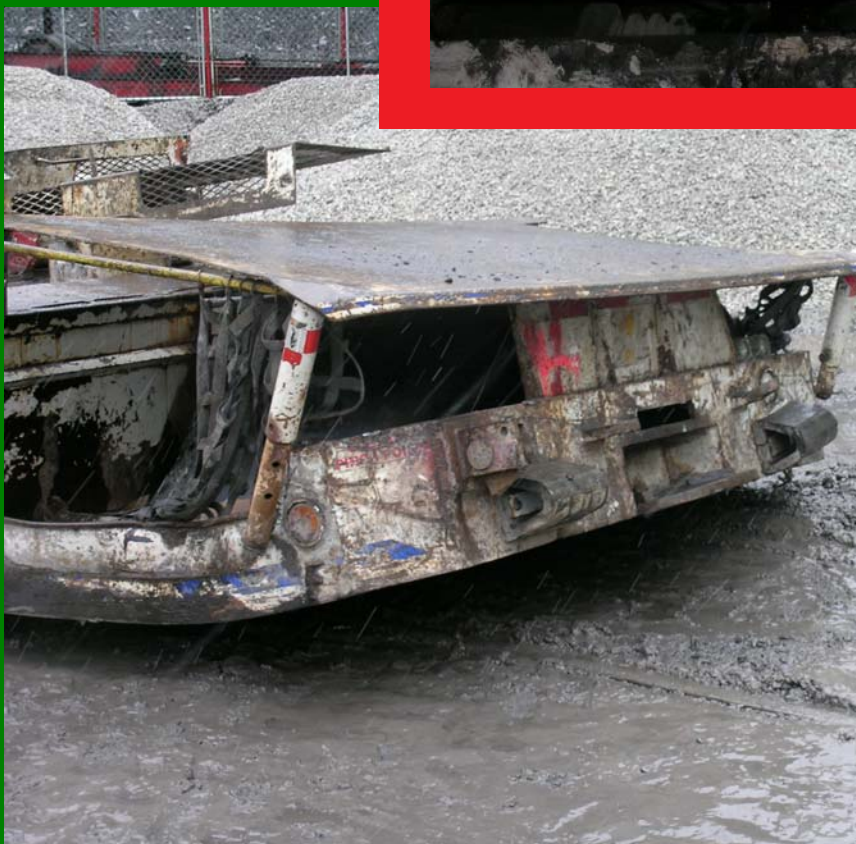
**Accident # 1:** After the service brake failed, a mantrip traveled down a mine grade and collided with another mantrip, causing injuries to three miners. The mantrip's brakes were contaminated with metal and a foreign fluid and the emergency brake actuator had been broken off. There was an accumulation of oil and grease on the brake disks, further reducing brake application.

Note accumulation of oil/grease on brake rotor.
